Manhole Inspection Summary

Manhole # S71A1_001MH

Record Plat: **71A1** Node: **001** Status: **Found**

Location Address: **Cameron Dr.**

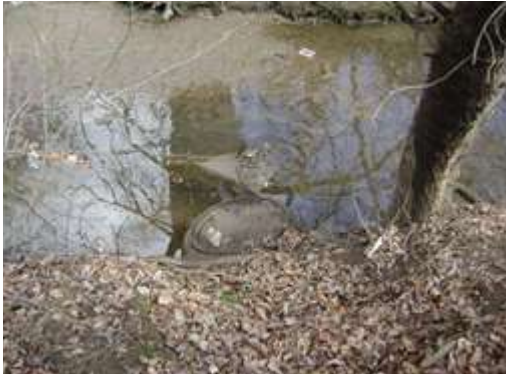
Defect 1

Frame and cover in the river. . Has been repaired by City crews.

Comments **CONTACTED 311 CALL CENTER TO REPORT PROBLEM. THE CONFIRMATION NUMBER WAS 87588. CITY HAS REPAIRED MANHOLE.**

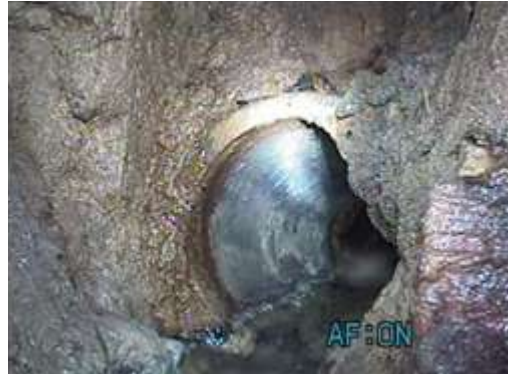
Defect 2

Infiltration in barrel around incoming 3 o'clock

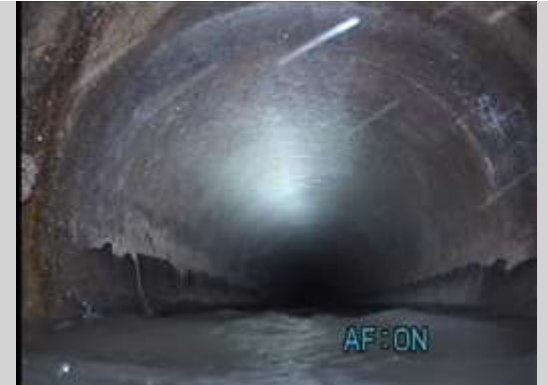
12 O'Clock Outflow

30 in. Circular Gravity Sewer
Pipe Out @ 12 O'Clock

Pipe Height: **30** (in.) Rod and Bar (Angled)
Pipe Material: **Concrete** ☐ Pipe Lined
Invert Depth: **18.17** (ft.) Flow Characteristics: **Fast**
Deposits: ☒ None ☐ Mud ☐ Sludge ☐ Debris ☐ Grease
Silt Depth: (in.) Deposits Extent:
Infiltration: **None** Pipe Seal Cond: **Sound**

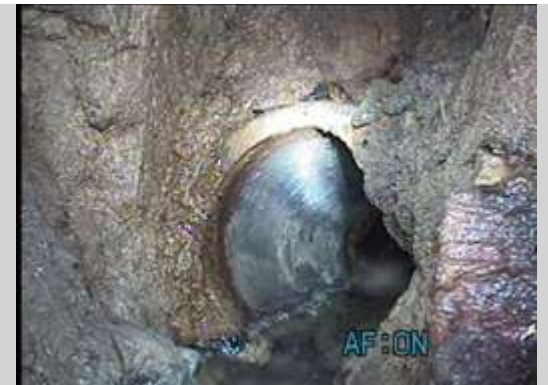
3 O'Clock Inflow

8 in. Circular Gravity Sewer
Pipe In @ 3 O'Clock

Pipe Height: **8.4** (in.) Rod and Bar (Angled)
Pipe Material: **Clay** ☐ Pipe Lined
Invert Depth: **16.25** (ft.) Flow Characteristics: **Fast**
Deposits: ☐ None ☐ Mud ☒ **Sludge** ☐ Debris ☐ Grease
Silt Depth: **0.25** (in.) Deposits Extent: **Light**
Infiltration: **Evidence** Pipe Seal Cond: **Unknown**

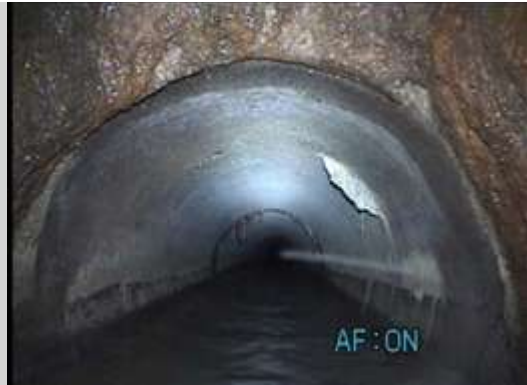
6 O'Clock Inflow

30 in. Circular Gravity Sewer
Pipe In @ 6 O'Clock

Pipe Height: **30** (in.) Rod and Bar (Angled)

Pipe Material: **Clay** ☐ Pipe Lined

Invert Depth: **18.08** (ft.) Flow Characteristics: **Fast**

Deposits: ☒ None ☐ Mud ☐ Sludge ☐ Debris ☐ Grease

Infiltration: **None** Pipe Seal Cond: **Sound**
